THE INFLUENCE OF BALLAST FOULING ON TRACK SETTLEMENT

A RAMPERSAD, TB GEORGE, R MOKOENA, MB MGANGIRA & PJ GRÄBE*

Pavement Design and Construction, CSIR Built Environment, P O Box 395, Pretoria 0001,

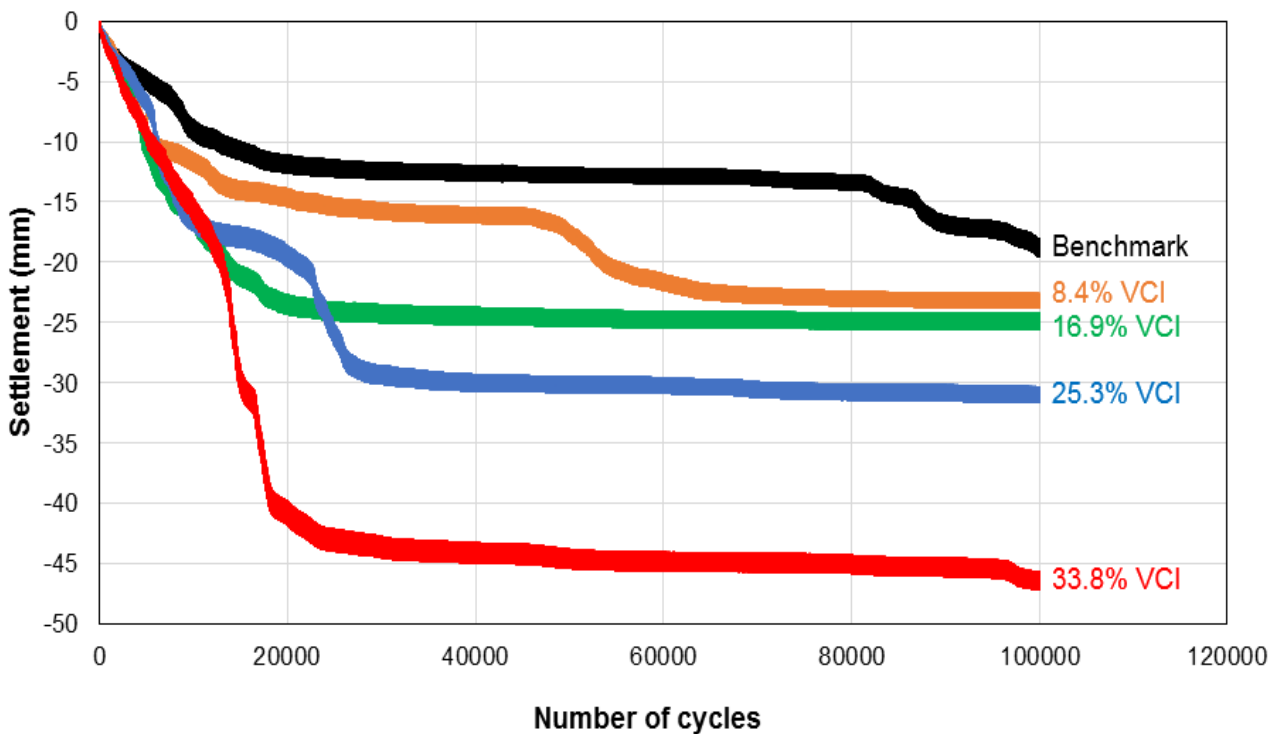
Figure 6: Box test settlement of fouled ballast

Figure 6 depicts the box testing of fouled ballast at varying void contamination indices (0 [benchmark], 8.4, 16.9, 25.3 and 33.8 %). The thick bands of the graphs are attributed to the cycling loading from the MTS® hydraulic actuator. It can be seen that as the VCI increases, the settlement also increases. The sudden dips in the settlement of all the testing (except the 16.9 % VCI) may be attributed to the breaking of individual ballast particles. The results indicate an increase in settlement of between 11.7 and 40.2 % VCI per 10 % increase in coal contamination.

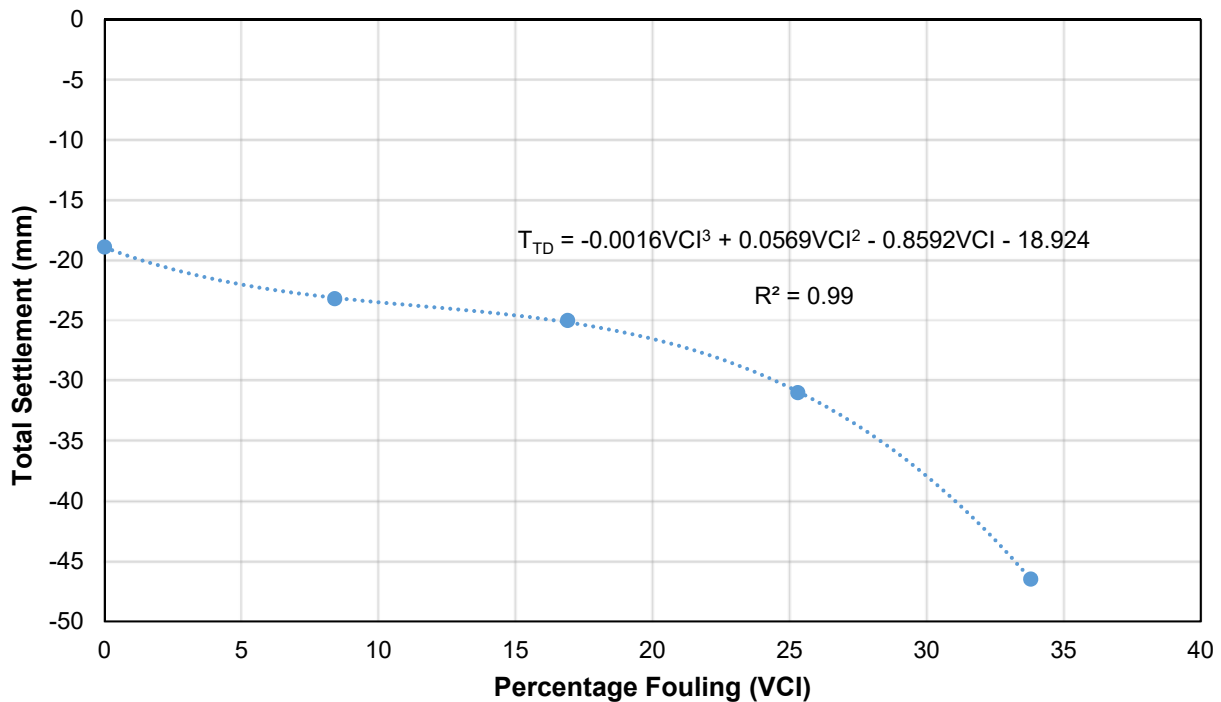
Figure 7: Total settlement per VCI of fouling

Figure 7 depicts the total settlement per VCI. Current practice does not state the total settlement in which maintenance is to be done. The VCI limit is the point at which no further settlement would occur with an increase in contamination. The limit cannot be observed and it may be necessary to increase the degree on contamination. The possible ballast breakages are part of the analysis and form part of a function for the final settlement. A polynomial trend line to the third degree is depicted in Equation 2 for the total settlement (T_{TD}) per VCI at 100 000 cycles. There is a very good correlation of the data with $R^2 = 0.99$.

$$T_{TD} = -0.0016VCI^3 + 0.0569VCI^2 - 0.8592VCI - 18.924 \quad (2)$$
